**Final Removal Action Completion Report
Olympic View Resource Area
Non-Time-Critical Removal Action
Tacoma, Washington**

**Prepared for
The City of Tacoma**

**March 28, 2003
7614**

**FINAL
REMOVAL ACTION COMPLETION REPORT
OLYMPIC VIEW RESOURCE AREA
NON-TIME-CRITICAL REMOVAL ACTION
TACOMA, WASHINGTON**

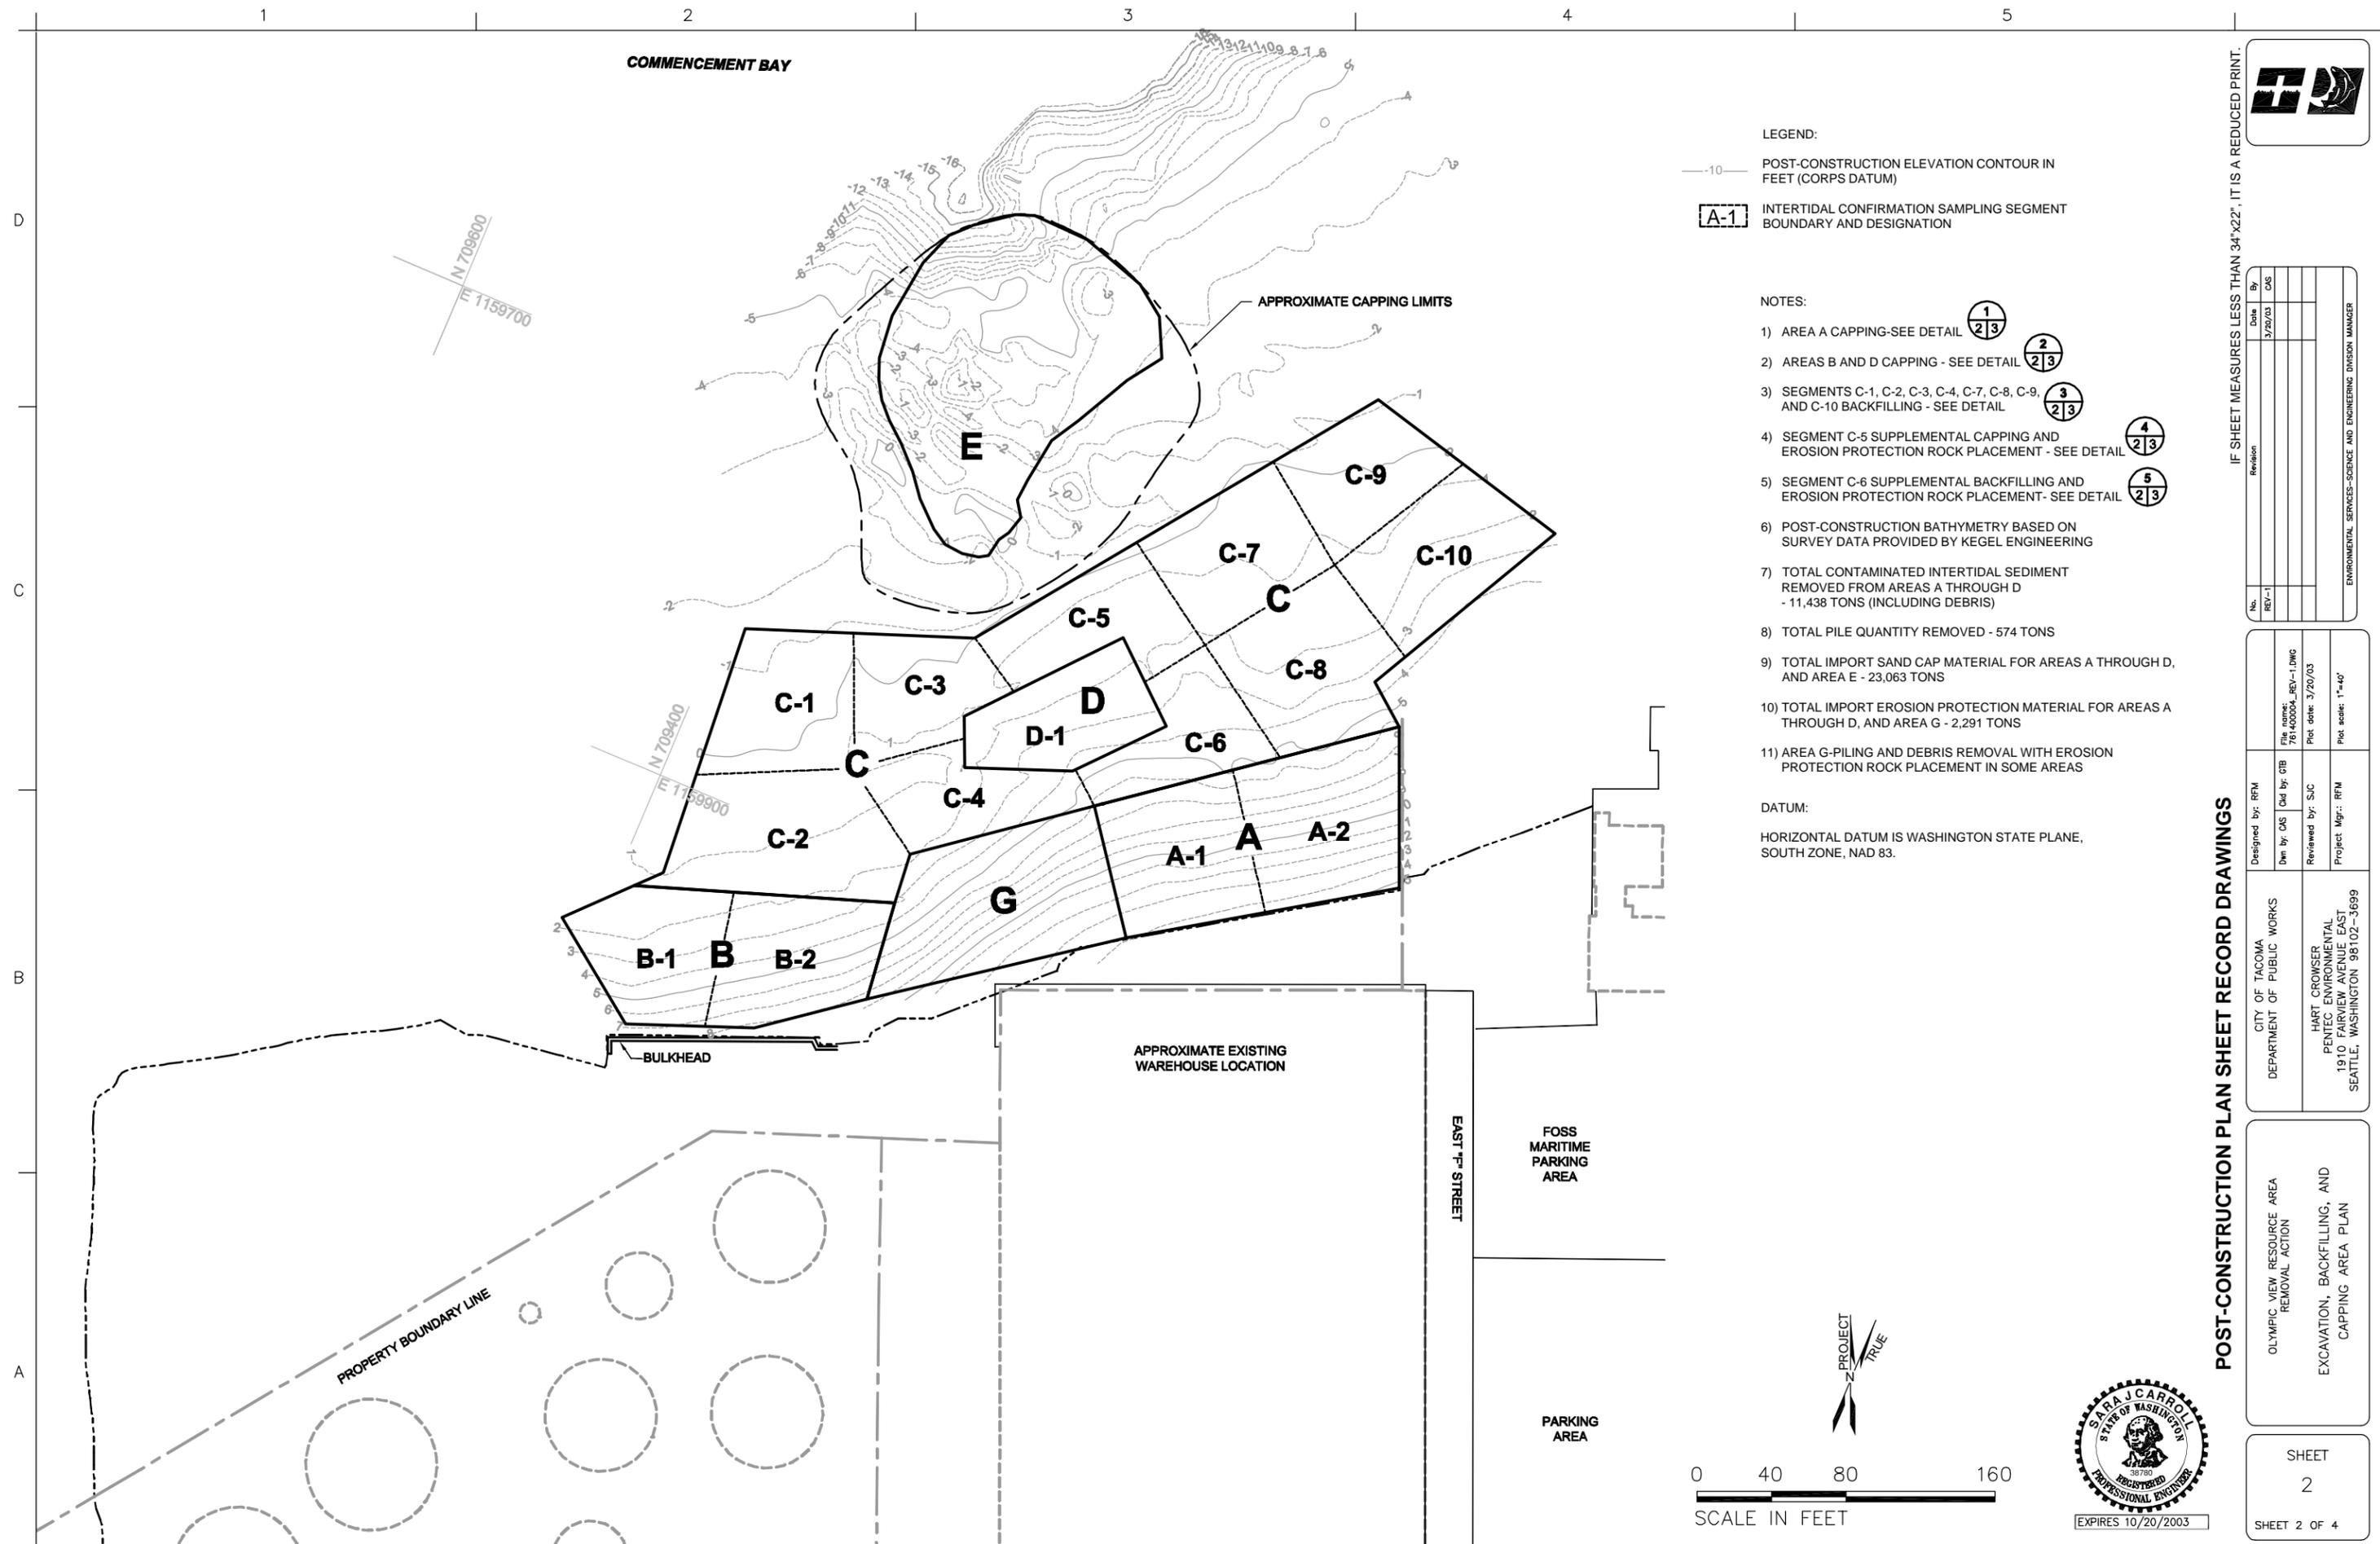
SHEET
2
SHEET 2 OF 4

OLYMPIC VIEW RESOURCE AREA
REMOVAL ACTION
EXCAVATION, BACKFILLING, AND
CAPPING AREA PLAN

Subtidal Area E was capped with approximately 7,965 tons of sand material placed from a barge-mounted tremie tube. The extent of capping for Area E is shown on Record Plan Sheet 2 of 4. Multiple placement efforts over several weeks were required to achieve the final bathymetric contour elevations. The capping material is expected to promote colonization by eelgrass and other benthic organisms over the restored area.

Area C excavation segments are identified on Record Plan Sheet 2 of 4, and Sheet 3 of 4. Sheet 2 of 4 also provides as-built bathymetry for capped and backfilled portions of intertidal area. The location of these areas conforms with the planned design areas. No field changes were made. With the exception of segment C-6, Area C sediments were removed to an average depth of 1.3 feet below the existing mudline. Minimum and maximum excavation cut depths were 0.9 and 2.9 feet, respectively. With the exception of two isolated points in segments C-8 and C-10, minimum excavation depths were greater than 1.1 feet. Thicknesses of backfilled segments in Area C ranged from 1.3 and 2.9 feet, with an overall average of 1.7 feet. Backfilling and capping efforts restored the intertidal beach surface to near the pre-existing grade. In addition, portions of Area C were further covered with a minimum 6-inch-thick layer of rounded river gravel for erosion protection, as shown on Record Plan Sheet 4 of 4. Excavation cut depths and sand placement thicknesses were consistent with project performance criteria.

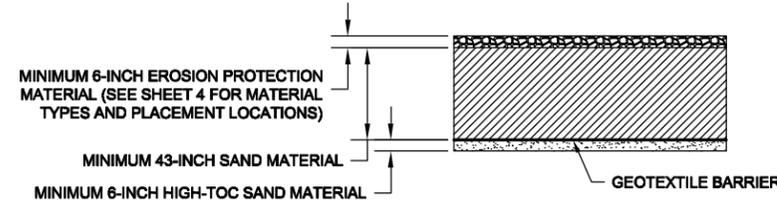
AREA B AND AREA D CAP DETAIL (TYP.)
NOT TO SCALE

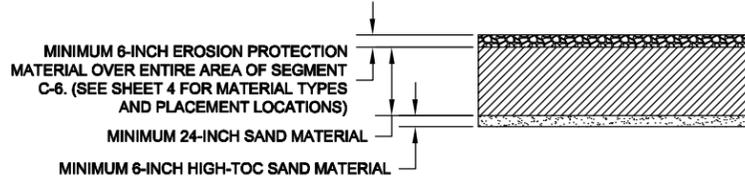
SEGMENT C-6 SUPPLEMENTAL BACKFILLING AND EROSION PROTECTION ROCK PLACEMENT DETAIL (TYP.)
NOT TO SCALE

- Segment C-6 was re-excavated to a minimum of 2.0 feet below the pre-existing grade and backfilled with a 0.5-foot layer of sand with high total organic carbon (TOC). Additional sand material was subsequently placed in segment C-6 between September 4 and 7 to a minimum thickness of 2.0 feet. The segment was then covered with a minimum 0.5-foot lift of erosion protection rock. This action provided a protective backfill cover for segment C-6 using the same concept as for Area B and Area D capping described below; and

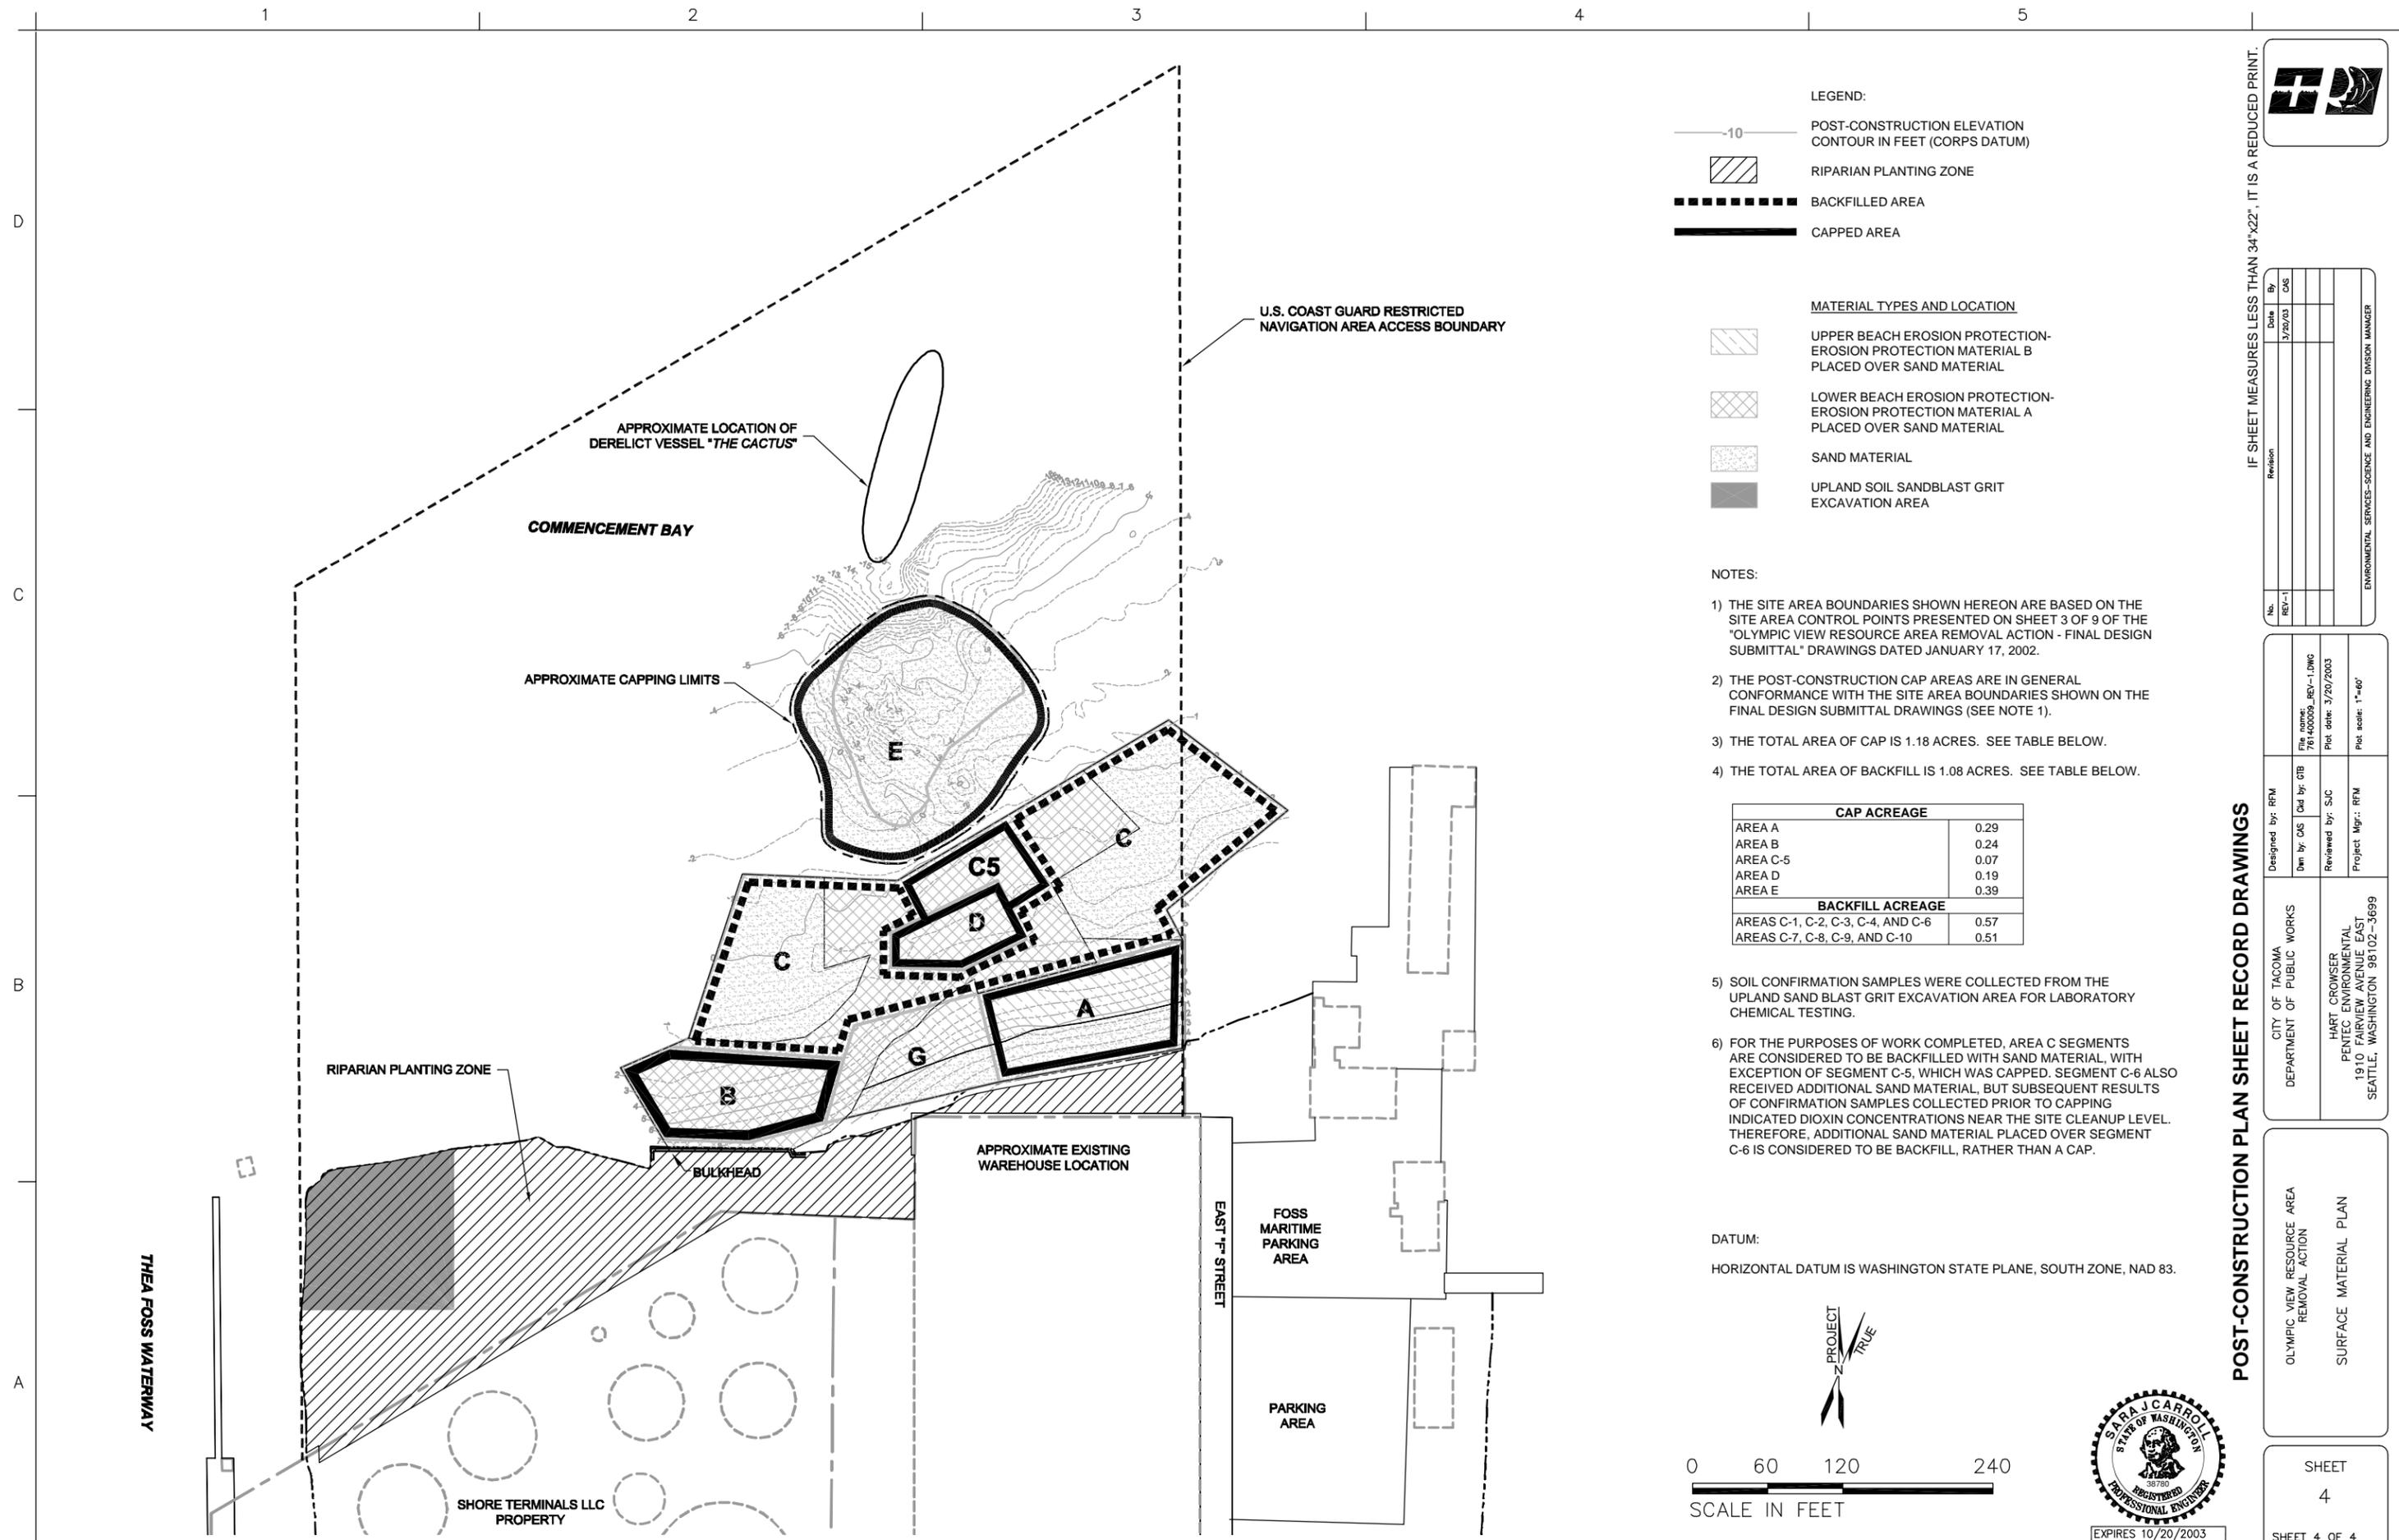
- 5) SOIL CONFIRMATION SAMPLES WERE COLLECTED FROM THE UPLAND SAND BLAST GRIT EXCAVATION AREA FOR LABORATORY CHEMICAL TESTING.
- 6) FOR THE PURPOSES OF WORK COMPLETED, AREA C SEGMENTS ARE CONSIDERED TO BE BACKFILLED WITH SAND MATERIAL, WITH EXCEPTION OF SEGMENT C-5, WHICH WAS CAPPED. SEGMENT C-6 ALSO RECEIVED ADDITIONAL SAND MATERIAL, BUT SUBSEQUENT RESULTS OF CONFIRMATION SAMPLES COLLECTED PRIOR TO CAPPING INDICATED DIOXIN CONCENTRATIONS NEAR THE SITE CLEANUP LEVEL. THEREFORE, ADDITIONAL SAND MATERIAL PLACED OVER SEGMENT C-6 IS CONSIDERED TO BE BACKFILL, RATHER THAN A CAP.

The selected design alternative for the OVRA Removal Action involved excavating 11,438 tons of sediment and debris from affected intertidal areas. Following excavation, 14,004 tons of sand backfill and capping materials were placed within these areas to restore intertidal habitat. In addition, a total of 2,291 tons of rounded river rock up to 6 inches in diameter were placed over portions of the restored intertidal areas to provide a minimum 6-inch-thick surface erosion protection layer. The areal extent of intertidal sand cap, backfilling, and erosion protection rock placed during construction is shown in

Soil with visible sandblast grit was discovered during clearing and grubbing near the western boundary of the site. The affected soils were removed to the excavation limits shown on Record Plan Sheet 4 of 4 and transported for off-site landfill disposal. Confirmation samples were collected from the area for chemical analysis. There is no indication of a residual condition that represents a threat to human health and the environment.

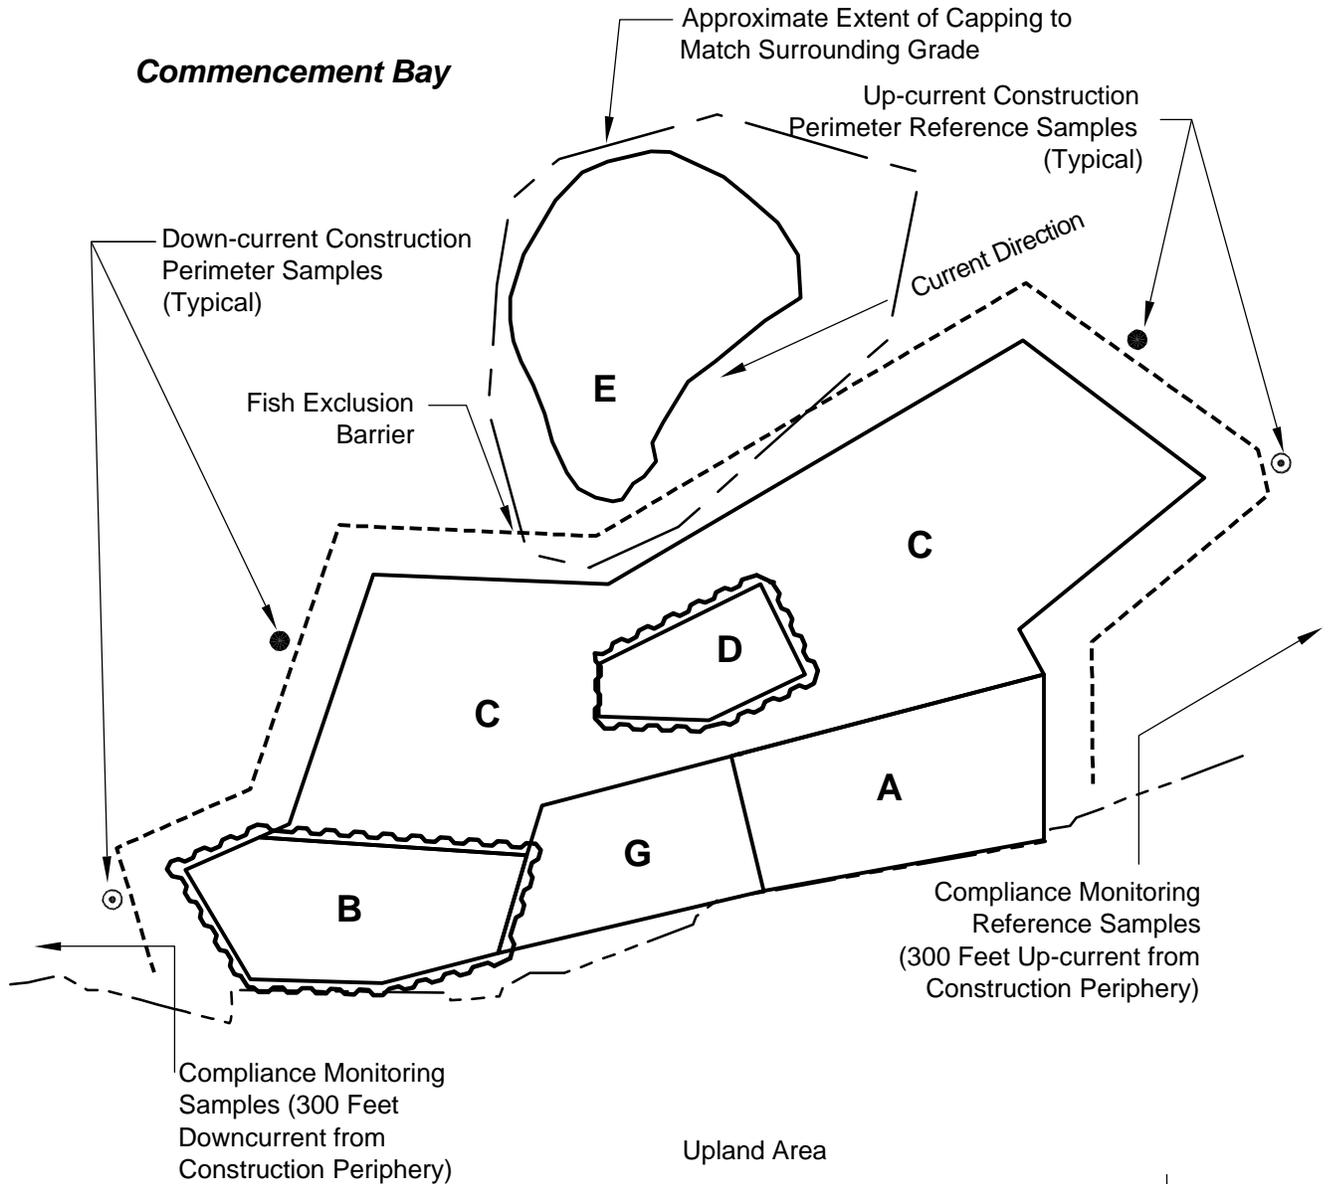
Water Quality Monitoring Location Plan

For intertidal areas, water quality monitoring was conducted at target up-current and down-current locations on the periphery of the intertidal construction area, as shown on Figure D-1. Each monitoring location was typically within about 10 feet of the outside of a fish exclusion barrier installed around the site work areas. In addition, monitoring at a point of compliance located 300 feet down-current of the construction area was planned if potential water quality concerns were identified at the construction perimeter locations. No potential water quality impacts were noted, and no point-of-compliance monitoring was conducted.
